# Manhole Inspection Summary

Manhole # S17YY1008MH

Insp Date: **11/6/06 10:45 AM**

**Location** Address: **2014 GREENBERRY RD**

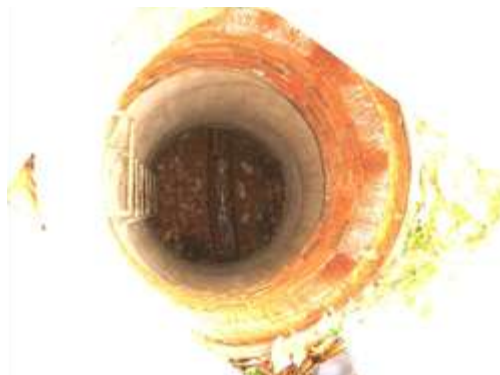
Top View

**Bench** ☒ Exists Material: **Brick** ☐ Parged ☒ **Debris** (not Condition related)

Bench debris.

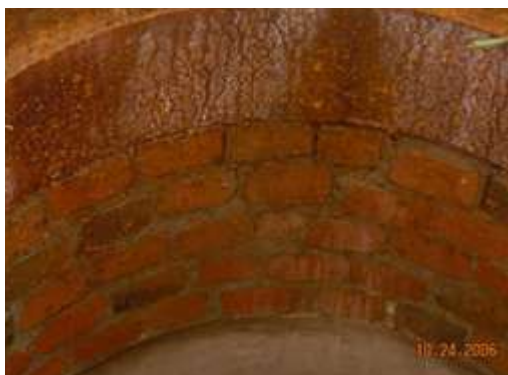
Defect

**Chimney / Frame Adjustment** ☒ Exists Material: **Brick** ☐ Parged Height: **12** (in.)

Condition: ☐ Sound ☐ Cracked ☐ Root Intrusion ☐ Loose Brick ☒ **Deteriorated**

Infiltration: ☐ None ☒ **Joint** ☐ Cracks ☒ **Mortar** ☐ Roots ☐ Wall

Adjustment deterioration and infiltration.

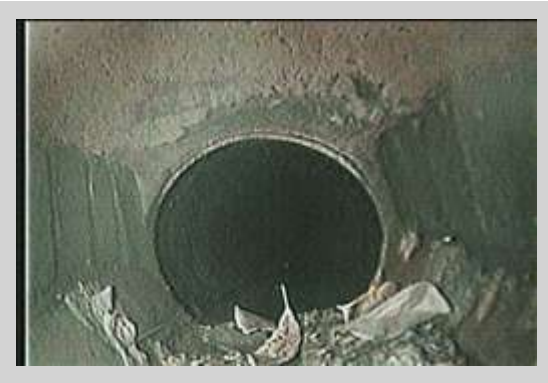
### 8 in. Circular Gravity Sewer Pipe Out @ 12 O'Clock

Deposits: ☐ None ☐ **Mud** ☐ Sludge ☒ **Debris** ☒ **Grease**

Silt Depth: **0.5** (in.) Deposits Extent: **Light**

Infiltration: **Evidence** Pipe Seal Cond: **Unknown**

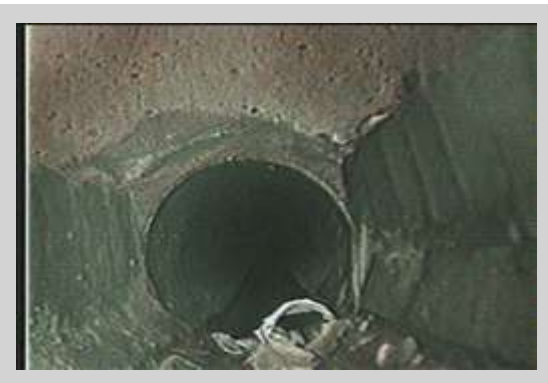
### 8 in. Circular Gravity Sewer Pipe In @ 6 O'Clock

Condition: ☐ Sound ☐ Cracked ☐ Root Intrusion ☒ **Deteriorated** ☐ Leaks ☐ Debris

Channel deterioration.

Deposits: ☐ None ☒ **Mud** ☐ Sludge ☒ **Debris** ☐ Grease

Infiltration: **Evidence** Pipe Seal Cond: **Unknown**
